SARMIZEGETUSA REGIA BETWEEN AN ARCHAEOLOGICAL SITE AND A NATURAL PROTECTED AREA. CULTURAL LANDSCAPE AS THE MISSING LINK

The present paper, based on the first extensive landscape and biodiversity study lead in Romania on an archaeological site, tackles the main problems generated by the double protection of the site of Sarmizegetusa Regia in Orăștie Mountains, the most iconic archaeological site of the Dacian period. Both part of the chain of Dacian fortresses enlisted on the UNESCO World Heritage List and part of the Natural Park Grădiştea Muncelului - Cioclovina (IUCN category V), the site of Sarmizegetusa Regia is facing serious management issues due to this dual strict protections systems. The paper will present a detailed analysis concerning the problems generated by the lack of harmonisation between the two management plans issued from two different types of protection, but also by the lack of a specific category of heritage and its specific protection instruments: the cultural landscape. The article aims to find, based on the site analysis, a series of landscape-based solutions for a coherent management plan, based on landscape values and methods, in order to respond to the

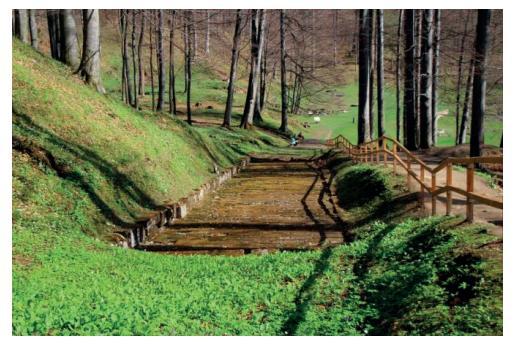
The roads from Dacia were, for the most part, natural, following without special setups the water courses or the ridges. Often the route of the ancient roads is perfectly visible on long sections to this day, for example in Căpâlna, Costesti and Sarmizegetusa. Some of these roads, described by C. Daicoviciu and H. Daicoviciu (1960), are no longer visible due to their coverage with vegetal layers and dry leaves. There were also paved roads such as the one from Sarmizegetusa Regia between the western civil neighbourhood, the fortification and the sacred area (Glodariu, 1983). Within the current visit route, the present arboreal vegetation has a positive effect on the perception of the ancient road due to the filtering of the images of the lower terraces, which unfold as a surprise during the site's visit, and create a vegetal arch along the route (Figures 4 and 5).

Figure 4. The axial perspective along the paved road made more dynamic by the rhythm of the trees

Figure 5. Section through the ancient paved road. Source: Personal archives/Tudora, 2018

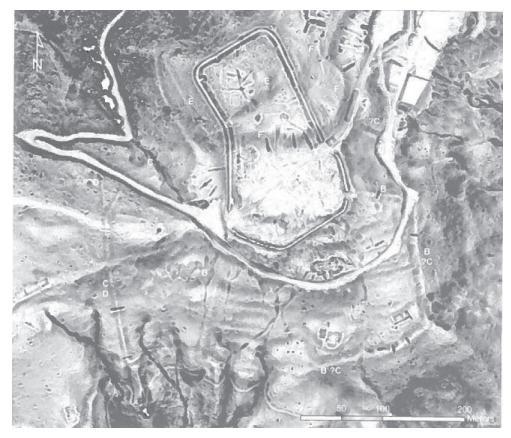
Figure 7. The present contour of the fortification mapped with LiDAR technology and the paths of the stone road (west) and the paved road (east). Source: I.A. Oltean and W.S. Hanson, 2017

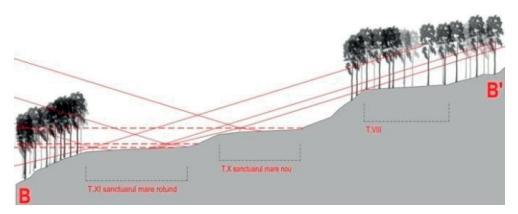
Figure 13. Section with the succession of the main terraces within the sacred area, Source: Tudora, 2018

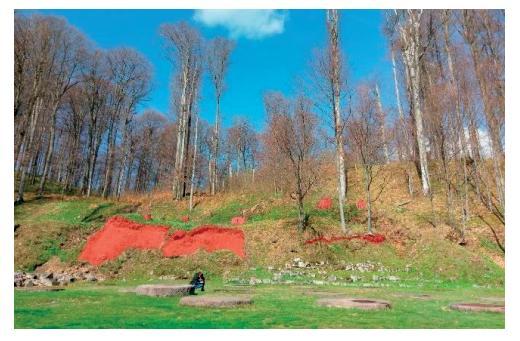
On the other hand, in this area, a number of problems caused by the presence or absence of arboreal vegetation become much more visible. Thus, some of the slopes from the terraces show stability problems, the roots of the trees located on the cornices leading to the fragmentation and the collapse of the slopes (Figure 14). The most serious such situation is represented by the pentagonal tower, partially destroyed by the push generated from the trees that collapsed over time (Figure 15).

Figure 14. Terraces IX and VIII seen from the terrace XI – the collapse of some slopes between terrace IX and VIII can be observed here, in the background it is also noticeable the mound within the fortification. Source: Culescu, 2018

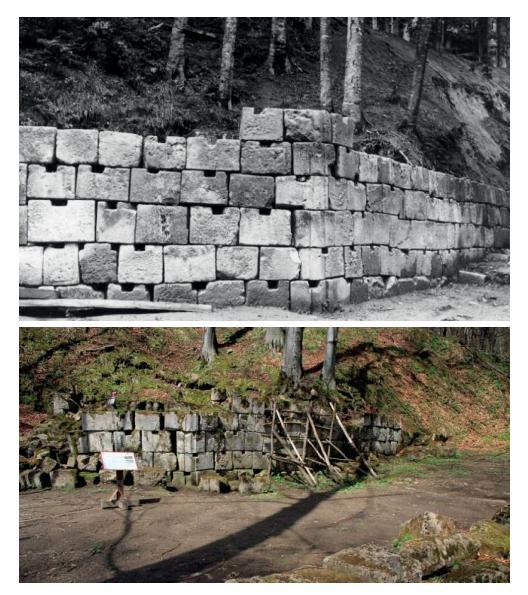
Figure 15. a. The pentagonal tower: photograph from the University Babeş-Bolyai archives (1960s) b. Current image: pressure created by trees on the wall and the destabilization of the terrain edge under the trees' weight are both visible. Source: personal archives (2018)

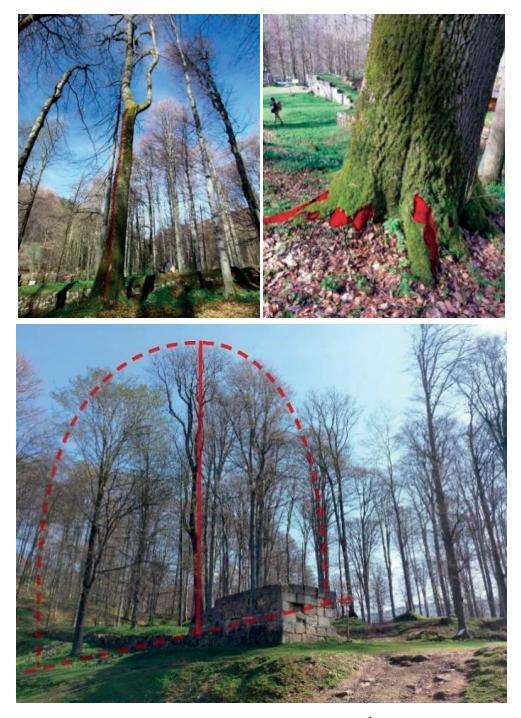
Figure 18. Cracks extended throughout the entire height of the trunk; injuries to the base of the trunk/the potential fall space, which intersects the fortress walls. Source: Culescu, 2018

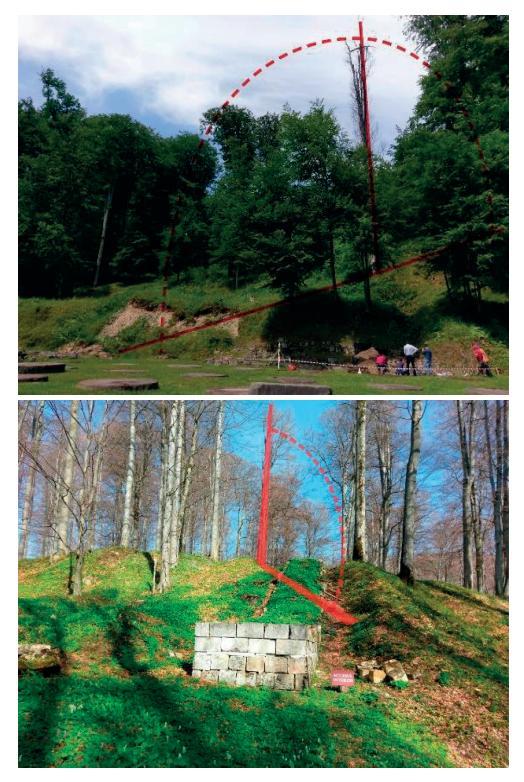
From the health point of view, broadly speaking, the general state of the tree vegetation within the site is currently relatively precarious. Many of the trees placed in the vicinity of the areas used by visitors or near the archaeological components exhibit a series of problems (open wounds, cracks, etc.) or deficiencies in the general architecture of the plant (broken branches, forks, stumps, etc.), some of them presenting the risk of collapsing and destroving the archaeological remains, as is the case with the ash (Fraxinus excelsior) located at the western gate of the fortress (Figure 18). This is not the only tree with the risk of collapse, such situations being found throughout the entire perimeter of the site (Figure 19).

Figure 19. The potential fall space for other trees with problems within the site that intersects other elements of the archaeological ensemble. Source: Culescu, 2018

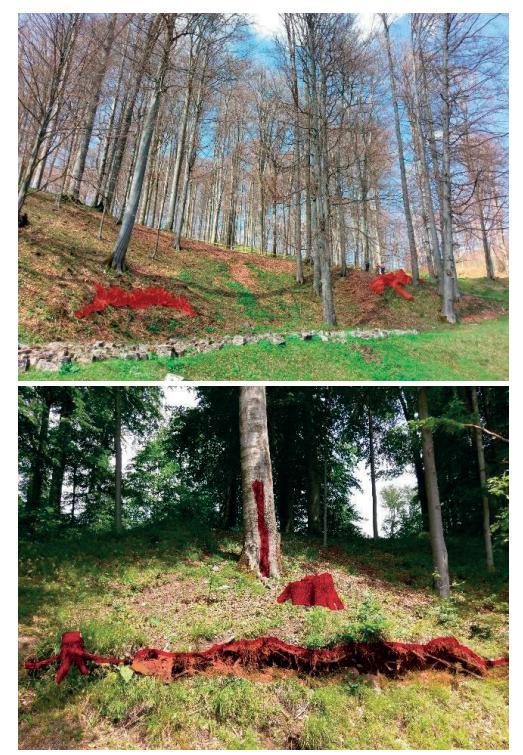
The trees located on the cornices of the terraces generate the danger of their collapse, thus leading to the destruction of the component structures of the Dacian fortress. These destructions, from the point of view of cultural heritage, are practically irreparable and irrecoverable (Figure 20).

Figure 20. Landslides and other problems associated to them. Source: Culescu, 2018

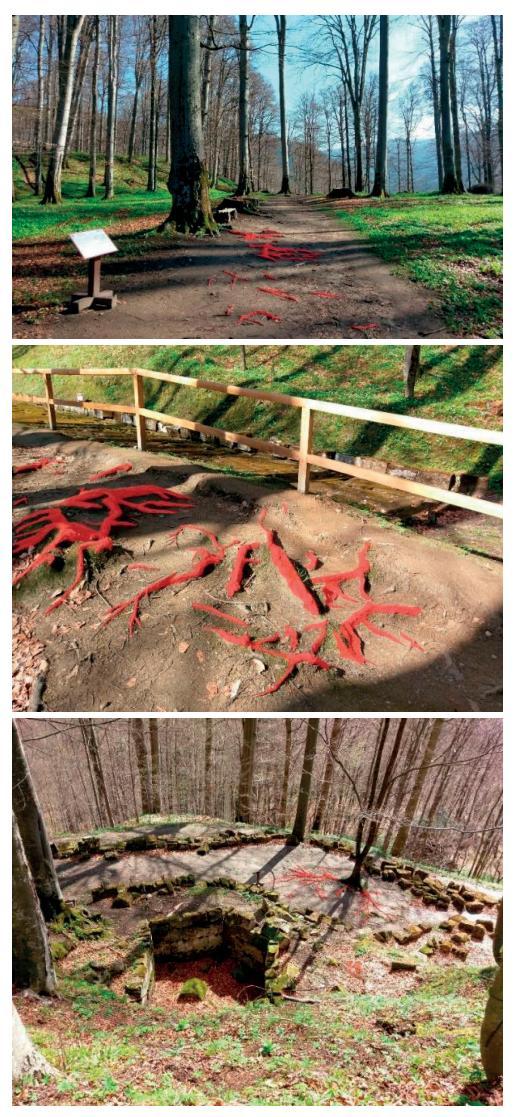
If the trees from the site can have somewhat negative impact on the general status and safety of the archaeological remains, as well as the safety of the visitors, in turn the visit of the site, in the absence of properly marked routs, leads to the alteration of the arboreal vegetation. Of the effects of improper site setup or lack of it, we mention here only two aspects. The first is related to the visiting routes that are not properly made or maintained. This results in the exposure of the roots and can, in time, determine the destabilization of the affected specimens. Injuring or cutting the roots opens new gates for diseases and pests, thus leading in time to the debilitation of the trees. Moreover, because those problems cannot be detected visually, it is difficult to know where and how to intervene, in a timely manner, in

order to stop or to slow down the debilitation (Figure 21).

Figure 21. Tree roots of exposed due to the usage patterns. Source: Culescu, 2018

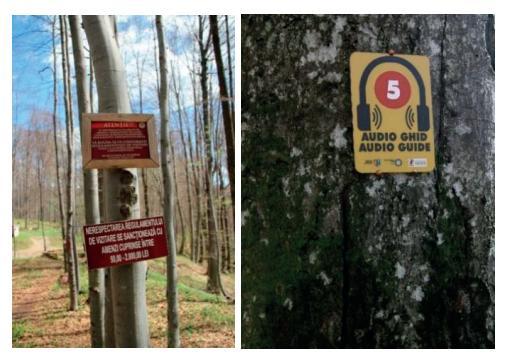
Another aspect related to the site management is the attachment of information panels or "site management tools" to the trees, which leads, in addition to the derisory image of the site, to injuring the trees and, subsequently, to generating other health problems for the affected trees (Figure 22).

Figure 22. Panels fixed on trees. Source: personal archives (2018)

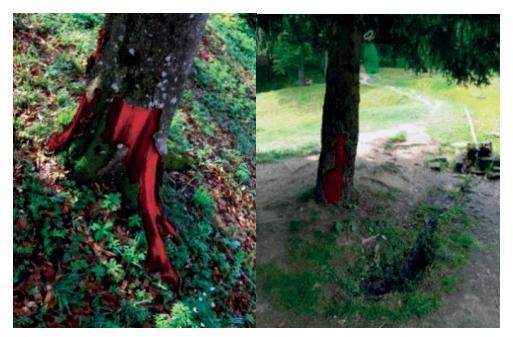
Regarding the state of the arboreal vegetation, two problems are recurrent, being encountered on this site for a large number of trees. One of these is the presence of the wounds at the base of the trunk (Figure 23) - a defect that, especially in the absence of an adequate maintenance process, questions the future integrity of the affected specimens.

Figure 23. Trees with wounds at the base of the trunk. Source: Culescu, 2018, p. 47

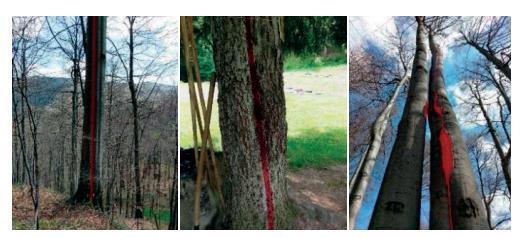
The second problem is the presence of cracks in the trunk (Figure 24) - an aspect that, in combination with the wind, can in time lead to the disintegration of the plants. The defective crown architecture contributes already very visible with trunk pressure forces. Also, the elimination of other trees can change the microclimate specific to each individual and, by exposing them to different wind directions and forces, it can potentiate the existing defects, ultimately leading to the loss of the affected plants.

Figure 24. Trees with cracks along the trunk.Source: Culescu, 2018

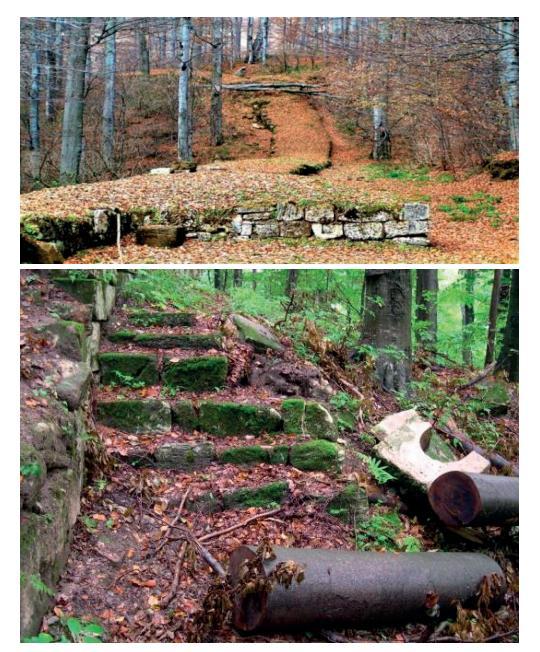
Our partial result concerning the landscape in general and the trees in particular are only pointing to the otherwise chronical problems of the Sarmizegetusa Regia archaeological site that is, for the most part, not valorised and inaccessible. The degradation of the vegetation and its poor maintenance lead to the destruction of this archaeological site of world importance. Within its perimeter, the interventions on the trees are allowed only at the request of the specialized bodies (to read forestry bodies), in order to carry out the works of repair, current maintenance. archaeological research. restoration, consolidation and conservation of the historical monument. The real problem is that these interventions cannot be performed at the request of the site administration or the archaeologists who work on the site and are prone to react only to the danger of destroying the components of the historic ensemble. In addition, when these interventions are carried out, the protection measures are unsuitable or lack completely from the execution process, and this has already generated additional damage. The way of organizing the tree cuts, the lack of protection measures and the approach of the site only as a part of the forest generates irreparable damage (Figure 25).

Figure 25 a. Trees collapsed due to natural causes (2012). Source: http://www.anchetadehunedoara.ro/sarmizegetua-regiao-istorie-furtunilor-care-au-devastat-monumentulunesco-ii// b. Trees collapsed following cuts. Source: personal archives (2018)

To ensure the success of the maintenance of the arboreal vegetation it is recommended to appoint a so-called gardener of the site, respectively a professional - preferably with experience in the field of arboriculture - who will come to know in detail the condition of the trees that form the vegetal ensemble. Thus, the interventions carried out on each tree will take into account its vulnerabilities, its strengths, etc. and to ensure continuity and consistency in decision-making regarding tree interventions.
